Measure 4: Pedestrian Activity at Bus Zones

Monitoring Objectives

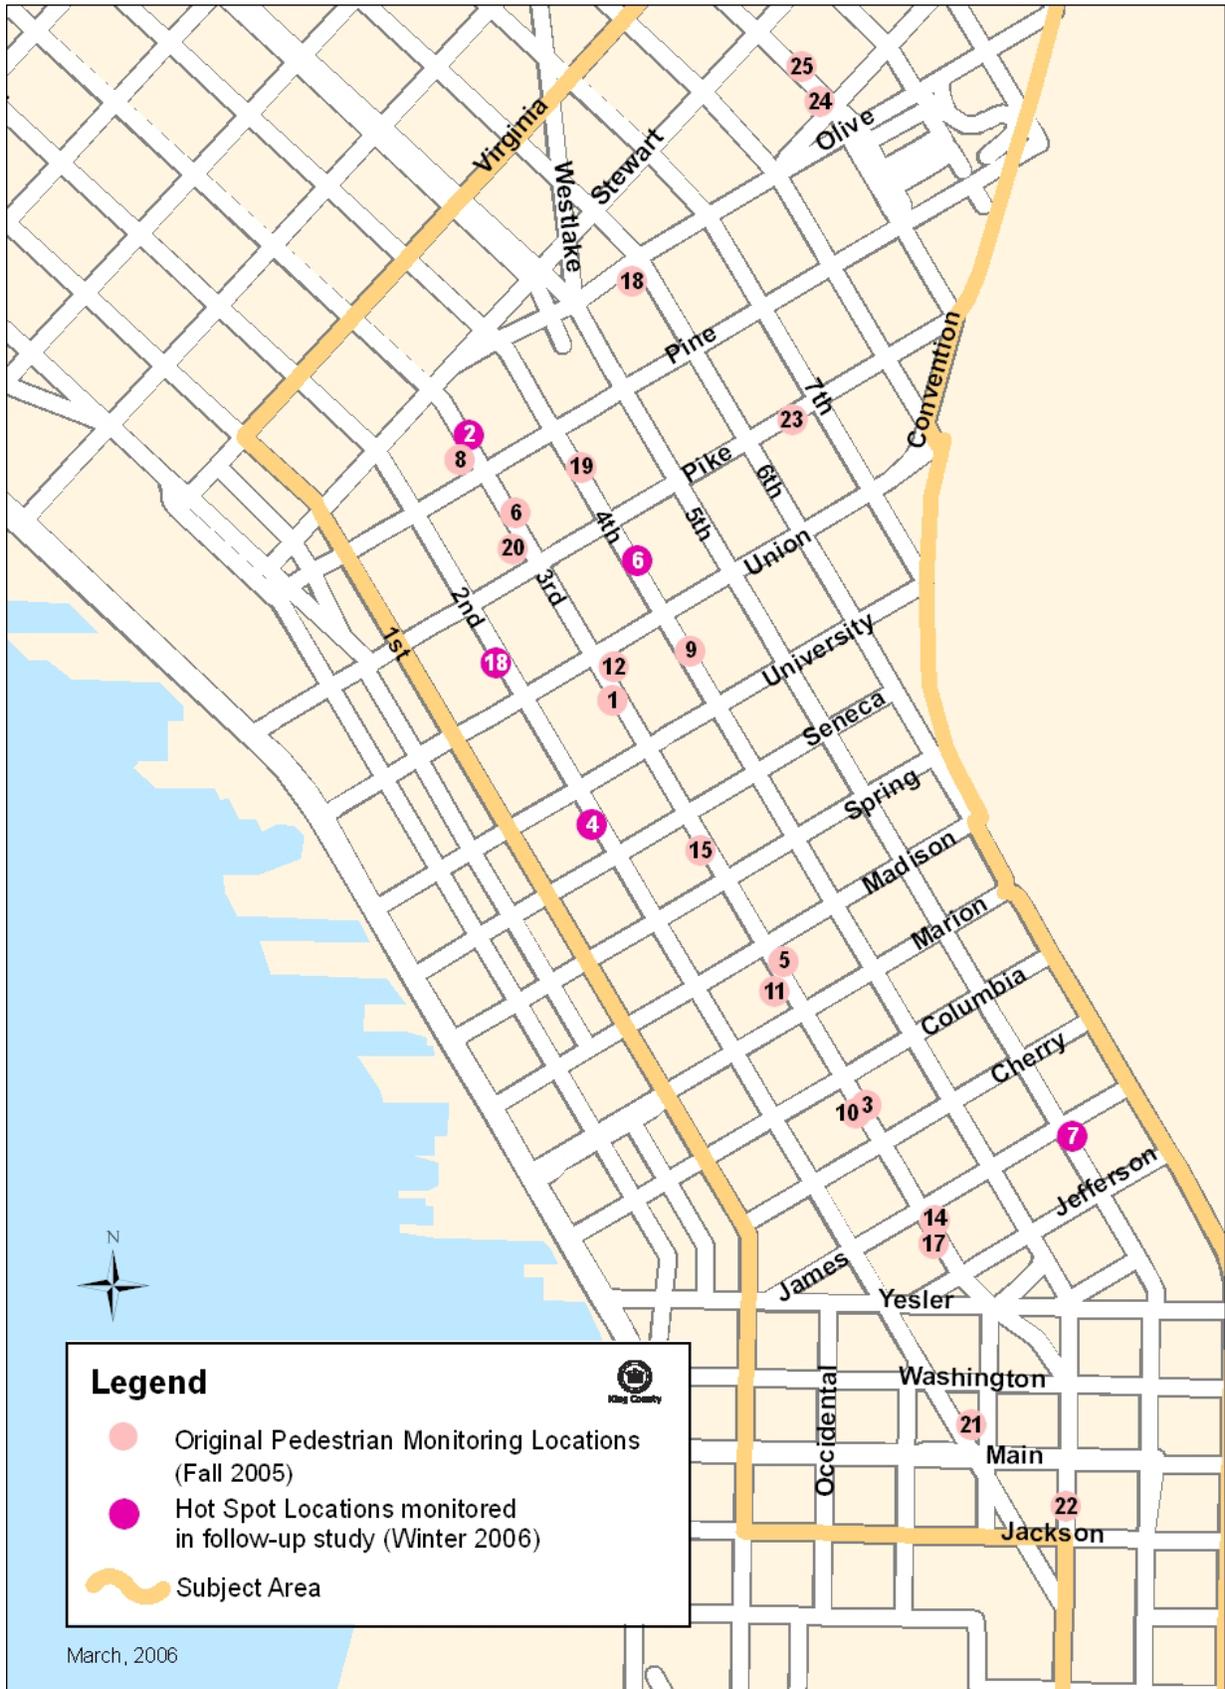
Figure 9. Bus Stops Surveyed for Pedestrian Congestion Counts

To measure the pre-tunnel closure conditions, an initial pedestrian congestion study was conducted at 19 selected bus zones in spring, 2005¹. These results were reported in Volume 1. In the first after-tunnel closure study, conducted in fall, 2005, 25 bus zones were studied, including newly installed bus stops². These results were reported in Volume 2. Based on these results, five of these locations were selected for further study, to be reported in Volume 3. These five zones were monitored to see if the level of service could be improved. The data presented in this third volume are the results of this follow-up study. The results from this follow study were compared with the fall, 2005 conditions, following tunnel closure. Figure 9 shows the 25 bus stops that were surveyed in the fall, 2005; the 5 zones that were identified for additional evaluation are highlighted.

Figure 10. Walking Pedestrian Rank and Level of Service by Bus Stop (*Map ID# corresponds to locations shown on Figure 9*)

Figure 11. Standing Pedestrian Level of Service for Full Bus Stop Area and Critical Loading Zone (*Map ID# corresponds to locations shown on Figure 9*)
